Citizen Volunteer Water Quality Monitoring on Alabama's Coast

Dog River

Alabama Water Watch
August 2004

Introduction to the Alabama Water Watch Coastal Series

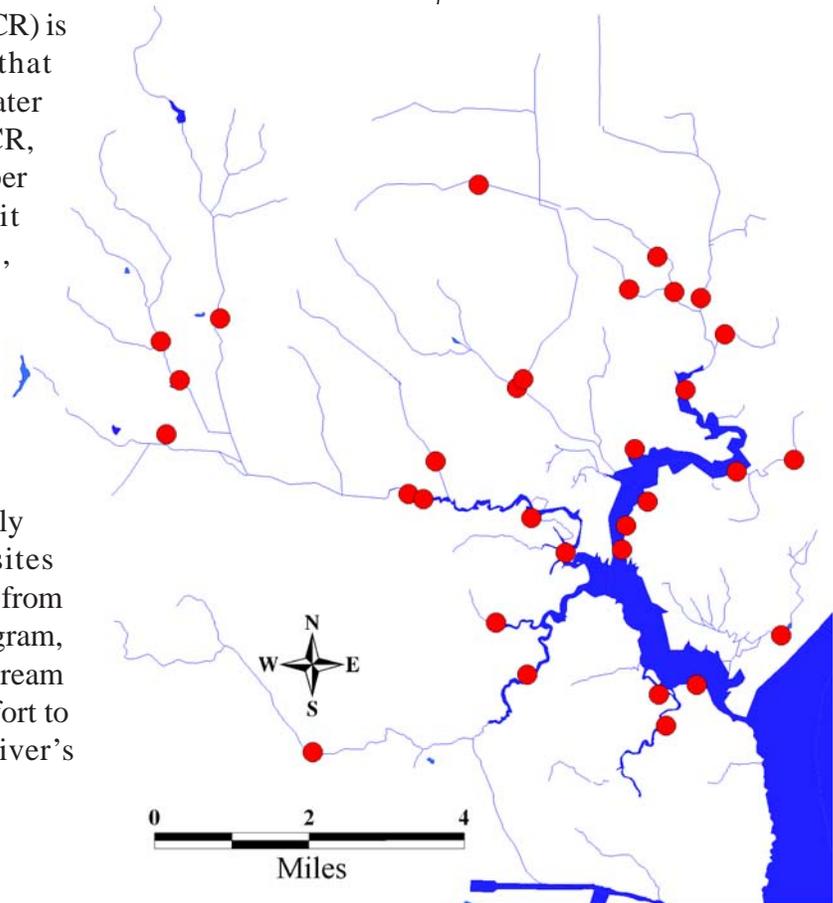
Dog River Clearwater Revival sampling sites (●)

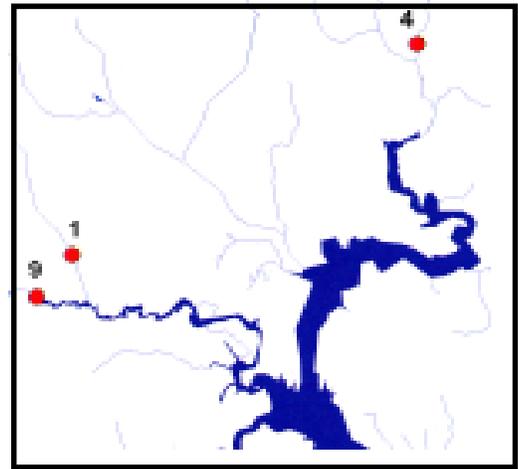
DRCR sites 1, 4 and 9 in the Dog River watershed

- The graphs on pages 6-8 document both seasonal and multi-year changes in water quality at three DRCR sampling sites (see map on p. 7). Each data point on a graph represents the average of one to several measurements per month.

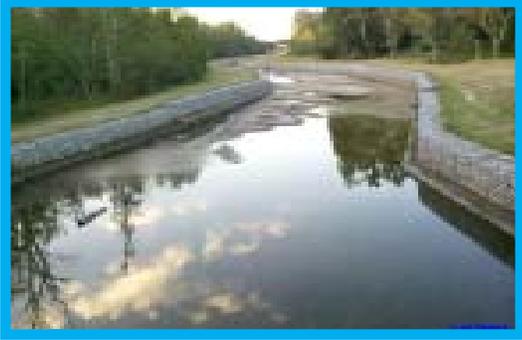
A channelized section of Spring Creek with streamside vegetation removed

- The water temperature of Spring Creek (Site 1) over the last five years seems to have an increasing annual range (higher in summer, lower in winter). This is probably because the streamside vegetation has been removed, exposing the stream to more sunlight and a wider range of air temperatures. The site also has had greater seasonal fluctuations in DO (black trend line) over time that may be related to changes in the streamside cover or flow. However, the DO has remained equal to or above 5 ppm.

- Alkalinity, hardness and pH values at Site 1 were all within expected, natural limits from 1999 through early 2002. Then, the values abruptly increased and alkalinity and hardness more than doubled. This appears to be a result of major channelization of Spring Creek, when natural, riparian vegetation was replaced with extensive limestone riprap. Limestone is calcium carbonate, which increases both alkalinity and hardness of water when it dissolves.

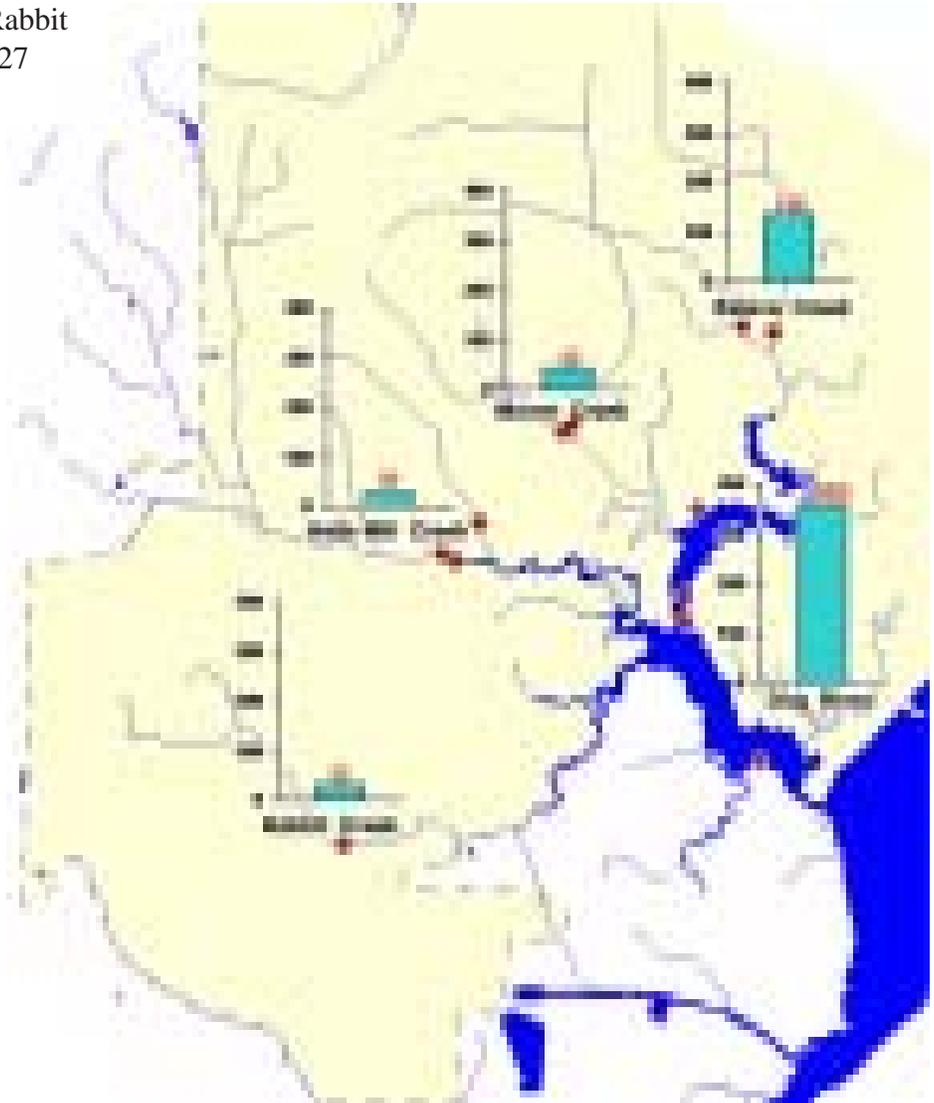
- A comparison of average water hardness values (concentration of calcium and magnesium) of four tributary streams and Dog River (a brackish water bay) reveals major differences within the watershed. Graphs are based on 940 hardness measurements at 12 DRCR sites (Sites 4 and 18 on Eslava Creek; Sites 2 and 3 on Moore Creek; Sites 1, 9 and 10 on Halls Mill Creek; Site 17 on Rabbit Creek; and Sites 6, 19, 20 and 27 on Dog River), collected from 1999 to 2004.

- Three of the tributary streams, Moore, Halls Mill and Rabbit creeks, had average hardness values of 28-43 mg/L, typical of “soft” waters of coastal areas. Dog River had a hardness that was about 10-times higher than these tributaries because it is tidally influenced and moderately brackish.

- The average hardness of two sites on Eslava Creek was more than 3-times higher than the other three creeks. The construction of Interstate 65 in the 1960s severed the headwaters from Eslava Creek and diverted them into Montlimar Canal. Because the stream is usually stagnant, it is more tidally influenced by high- hardness, brackish water of Dog River.

- AWW water monitors act as detectives that “sleuth out” causes and effects of water pollution, stream alterations or other changes that affect a waterbody. By overlaying graphs of DRCR water data on a map of Dog River, it is easier to understand what is happening to water quality throughout the watershed.

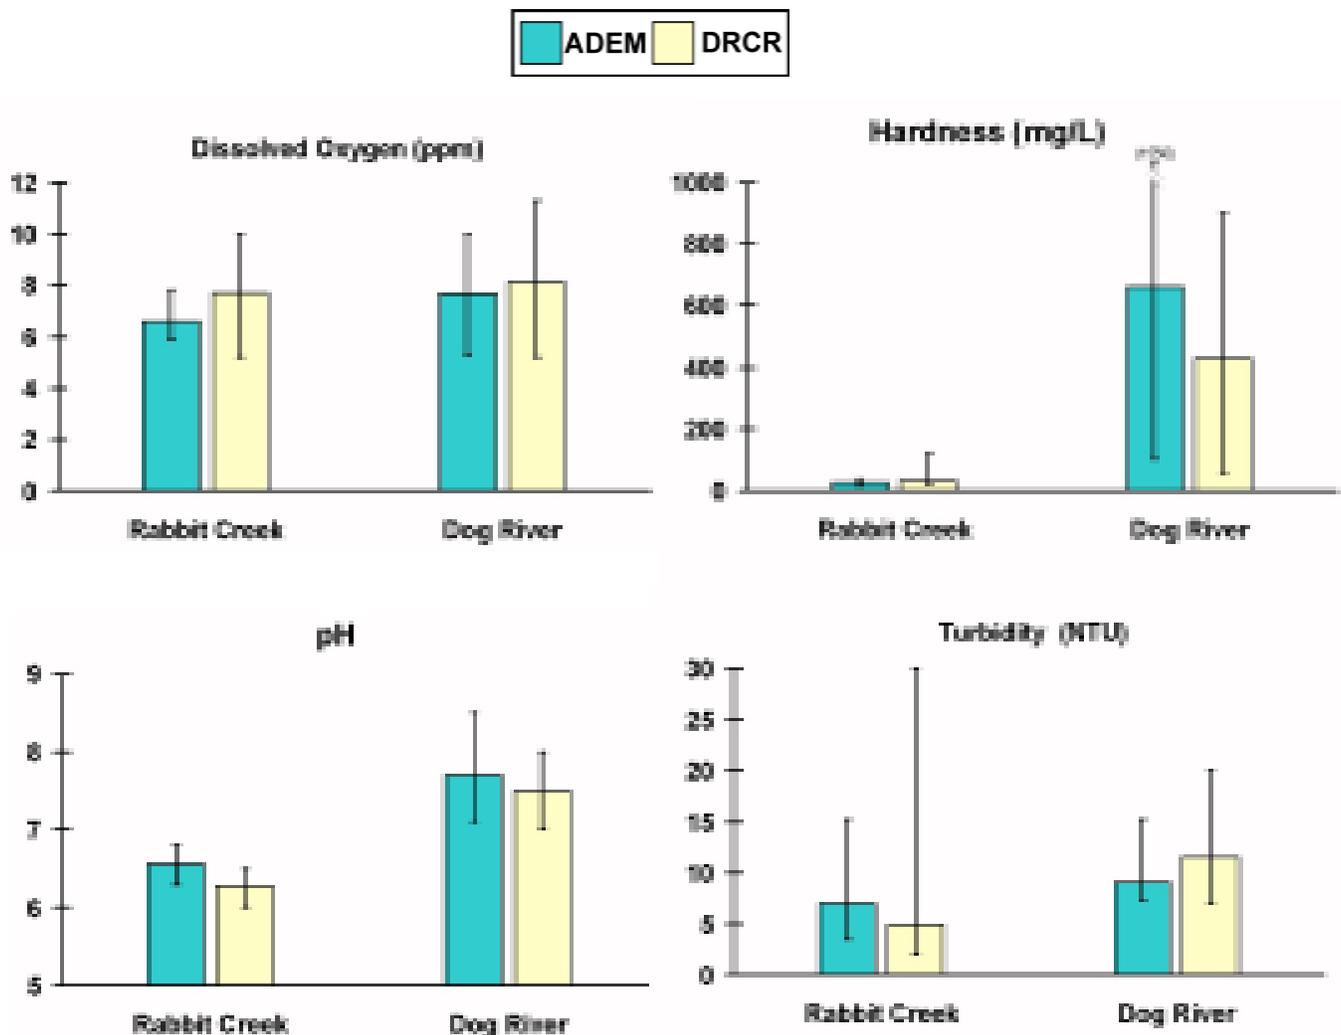
DRCR Sites 17 (06005017) and 8 (06005008) with ADEM sites RBTM-3 and DGRM-2 (ADEM 2003). Bars represent the average value of a parameter. Lines within bars represent the range of values.

- By comparing DRCR water chemistry data to professional data collected at about the same time and place, the credibility of the citizen data can be evaluated. In the graphs above, 41 records of DRCR from 1999-2003 were compared to 12 data records of the Alabama Department of Environmental Management (ADEM) from 2001.

- The two data sets were generally comparable and revealed water quality differences between Dog River and Rabbit Creek. Average dissolved oxygen, hardness, pH and turbidity were all higher in Dog River than in Rabbit Creek, as documented by both DRCR and ADEM. DRCR had more than 3-times the data records to substantiate these conditions, and they also are the only group collecting data from several other sites in the watershed.

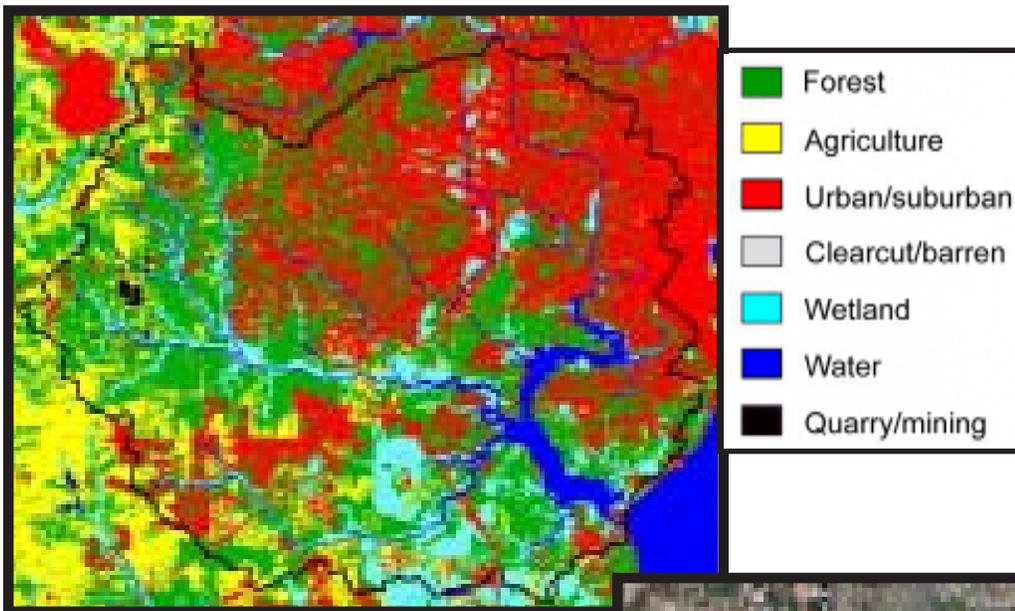
A land use map generated from 1992 Landsat satellite imagery of the Dog River watershed (delineated with black line)

- A comparison of these two watershed images indicates significant land use changes over a 10-year period. The 2002 image (right) shows evidence of increasing urbanization in the western and southern portions of the Dog River watershed.

- Relatively open, forested areas have decreased and developed plots have increased in the upper Halls Mill Creek and Rabbit Creek watersheds. Such development tends to decrease water infiltration and increase runoff that transports sediment, nutrients, pathogens and other pollutants to tributaries of Dog River.

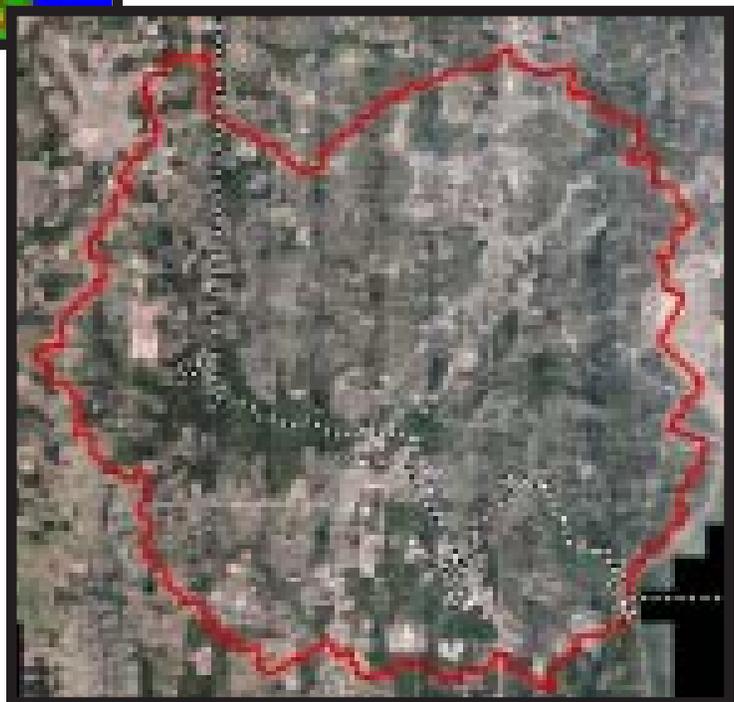
An aerial photograph taken in March 2002 of the Dog River watershed (delineated with red line) and Mobile City limits (delineated with dashed line). The City of Mobile GIS Department used color orthophotos to create this image.

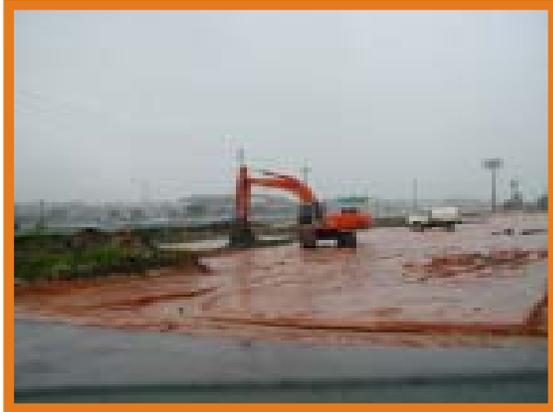
Commercial construction site in the Dog River watershed with minimal soil erosion control

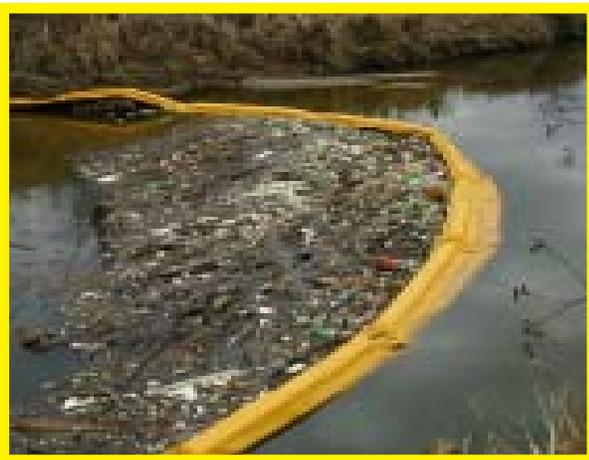
A sediment curtain on Moore Creek catches more litter than silt

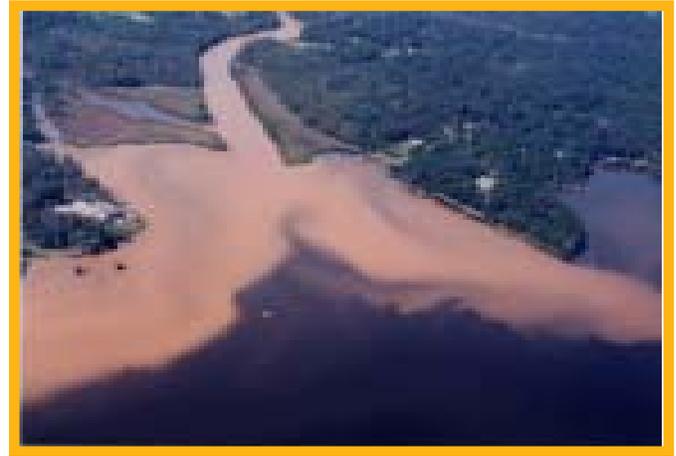
Aerial photograph, taken by Gerritt Carver in 1998, showing a sediment plume entering Dog River after heavy rainfall associated with Hurricane Georges.

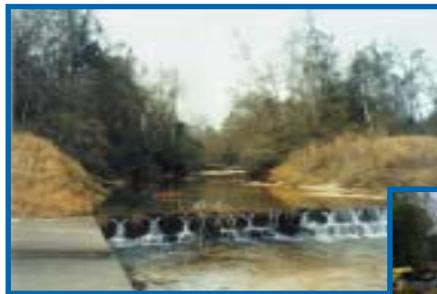
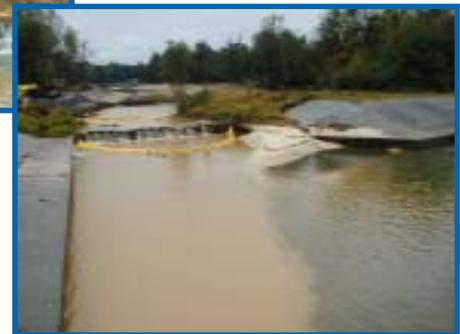
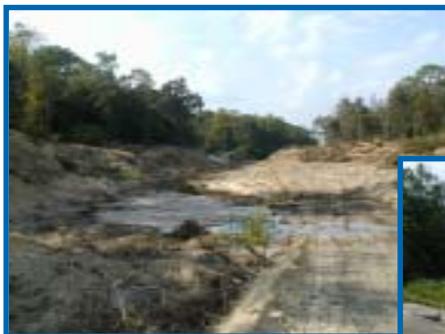
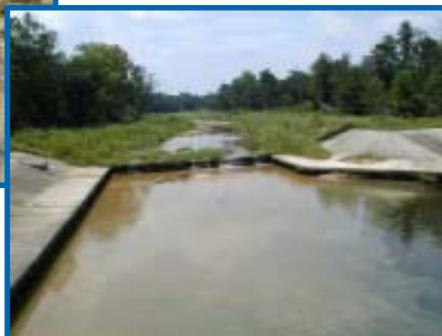
- This series of photos is of Moore Creek, an urban stream that has undergone extensive alterations.
- The City of Mobile has straightened and armored much of the channel to more efficiently convey stormwater runoff and prevent flooding and erosion.

- These changes protect homes and infrastructure from water damage, but essentially destroy much of the natural stream habitat and its aquatic life.
